**Bridge Inspection Report**

**STRUCTURE NAME:** SNODGRASS SLOUGH

3-SAC-Twin Cities Road

Bridge ID: 24C0053

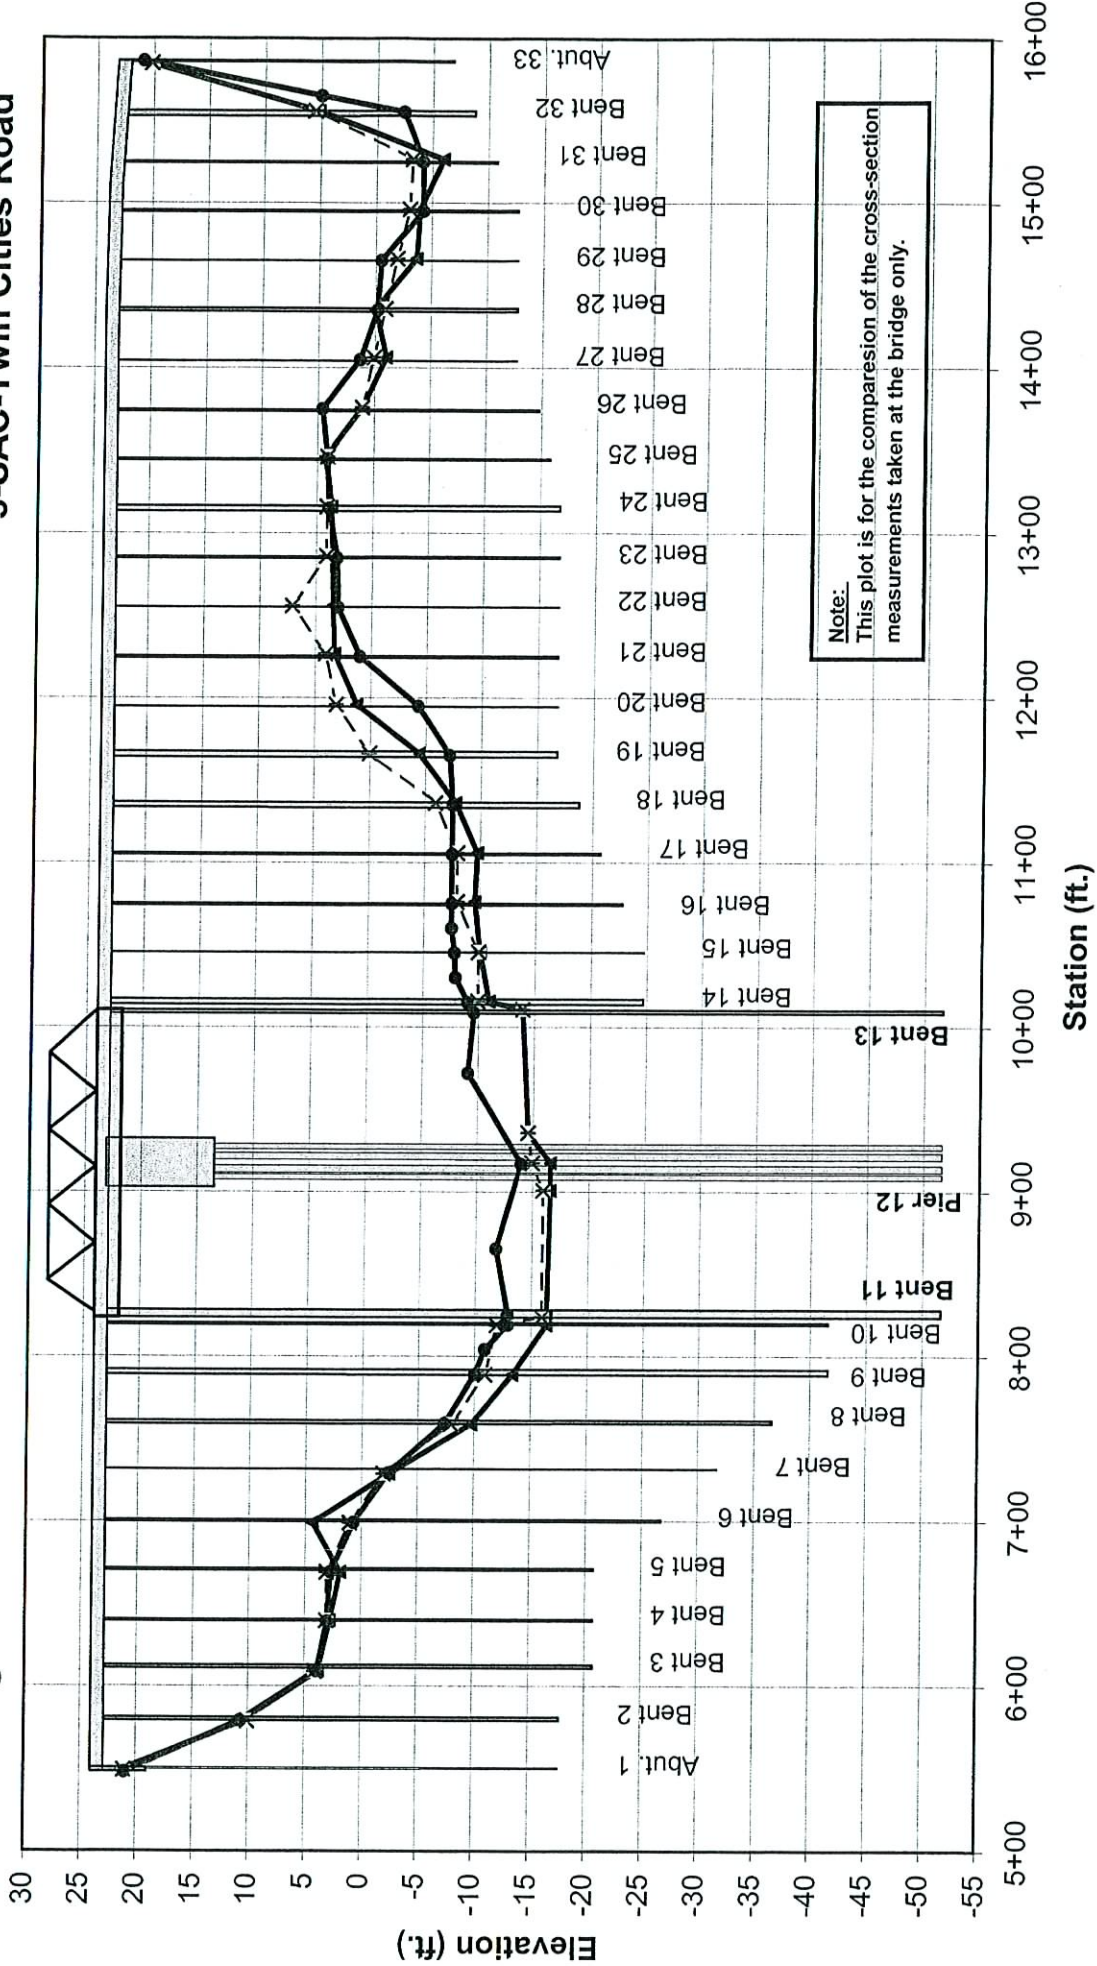
# Snodgrass - Upstream

Comparisons of the latest channel cross-section taken in 10/10/07 with two available previous cross-sections taken by the ABME teams in 1972 and 1993 show that the channel bottom has not significantly changed since 1972 and the channel has remained stable from span 1 through span 31 (see attached cross-sections plot). There is a deep drop in the upstream channel bottom elevation in front of Bent 32 column. It appears the channel has migrated east towards Bent 32. The piles at this bent and Bent 31 have a relatively short pile length. The loss of the channel grade could compromise the piles bearing capacity. However, we do not have a copy of the Log of Test Borings and therefore, cannot determine the remaining capacity at this time. This situation should be investigated by the local agency.

A Federal Highway Administration Memorandum dated April 27, 2001 has redefined the National Bridge Inventory Item 113 code description for U. This definition recommends that a plan of action should be developed and implemented to reduce the risk to users from a bridge failure during and immediately after a flood event. We recommend that the local agency develop and implement a Plan of Action for the subject bridge. We also recommend that the local agency investigate and address the loss of channel embankment adjacent at Bents 31 and 32.

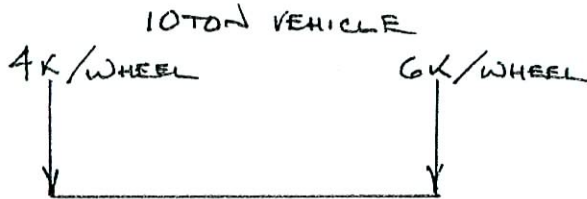
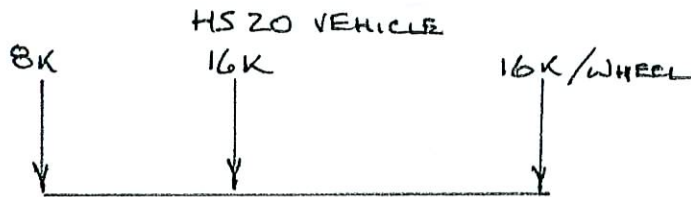
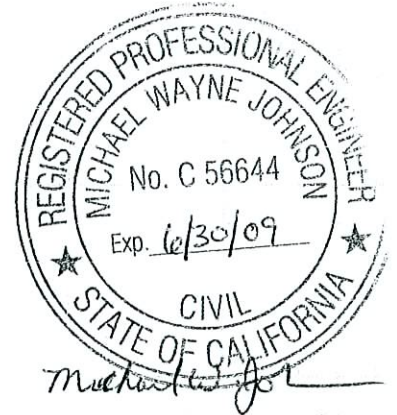
ASSUMED LOAD DISTRIBUTION

GROSS VEHICLE WEIGHT LIMITED TO 10 TONS

OPERATING RATING FACTOR =  $\frac{\text{WHEEL LOAD DISTRIBUTION, 10 TON VEHICLE}}{\text{WHEEL LOAD DISTRIBUTION, HS 20 DESIGN VEHICLE}}$

$$\text{OPERATING RATING FACTOR} = \frac{6K}{16K} = 0.375$$

$$\begin{aligned} \text{OPERATING RATING} &= (\text{OPERATING R.F.})(\text{G.V.W. HS 20}) \\ &= (0.375)(32.4 \text{ METRIC TONNES}) = 12 \text{ TONNES} \end{aligned}$$

$$\begin{aligned} \text{INVENTORY RATING} &= \text{OPERATING RATING} / 1.67 \\ &= (12 \text{ TONNES}) / (1.67) = 7 \text{ TONNES} \end{aligned}$$

NOTE: LOCALIZED DECK FAILURES INDICATE THE CORRUGATED DECK IS CONTROLLING THE LOAD CAPACITY OF THIS STRUCTURE. IT IS ASSUMED THE CORRUGATED DECK WAS DESIGNED USING A HS 20 DESIGN VEHICLE.
